**CITY OF CHICAGO
DEPARTMENT OF ENVIRONMENT
NARRATIVE**

Date: 10-27-04
Site: 11236 S. Torrence
Site Code: _____

SITE NAME: ACME Steel

SITE ADDRESS: 11236 S Torrence

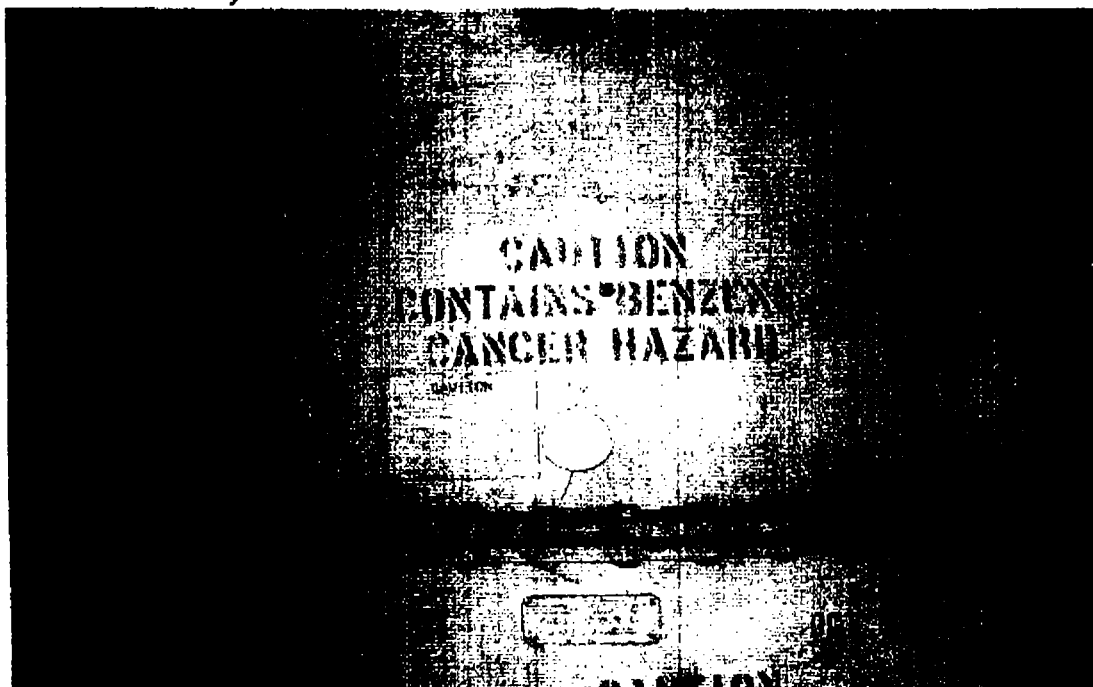
Roll # _____ Photo # 2 Direction West

1. There are 2 AST's located inside the Light Oil Building. The tanks are labeled " Caution Contains Benzens Cancer Hazard. I was unable to determine if the tanks are full. However, there is a trench / sump located inside the building filled with an unknown petroleum product. This trench leads outside the building into a concrete secondary containment heavily stained with a petroleum product (see photos #1, #2 & #3).

Comments: 1 of 2 Tanks located inside the light oil building with unknown contents.

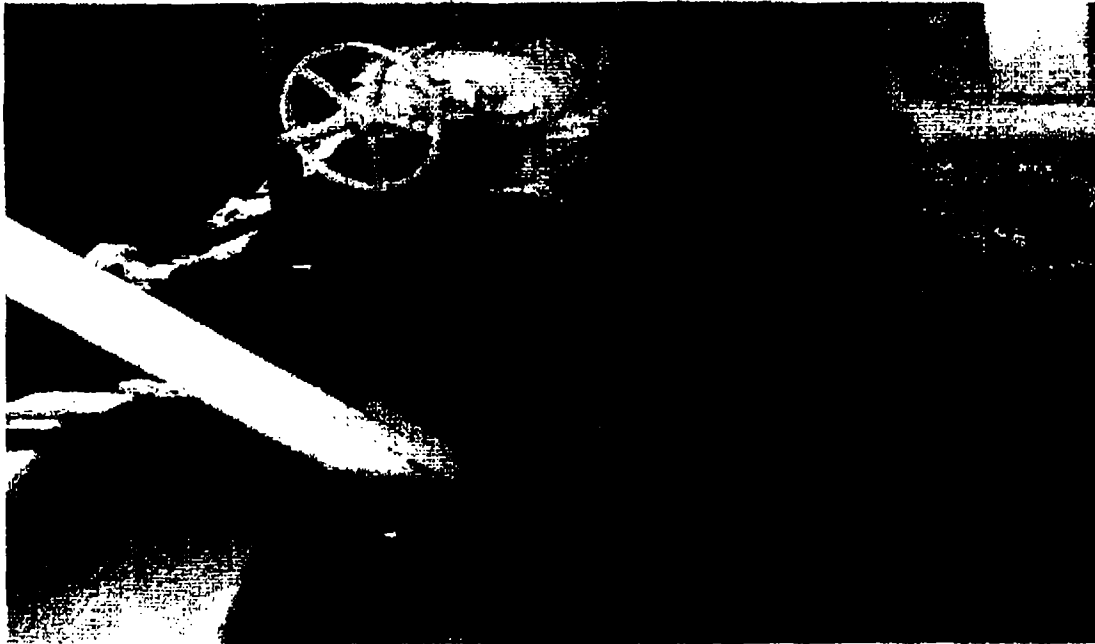
Roll # _____ Photo # 3 Direction South
Comments: Outside area of light oil building with secondary containment heavily stained + unknown liquid in trench.

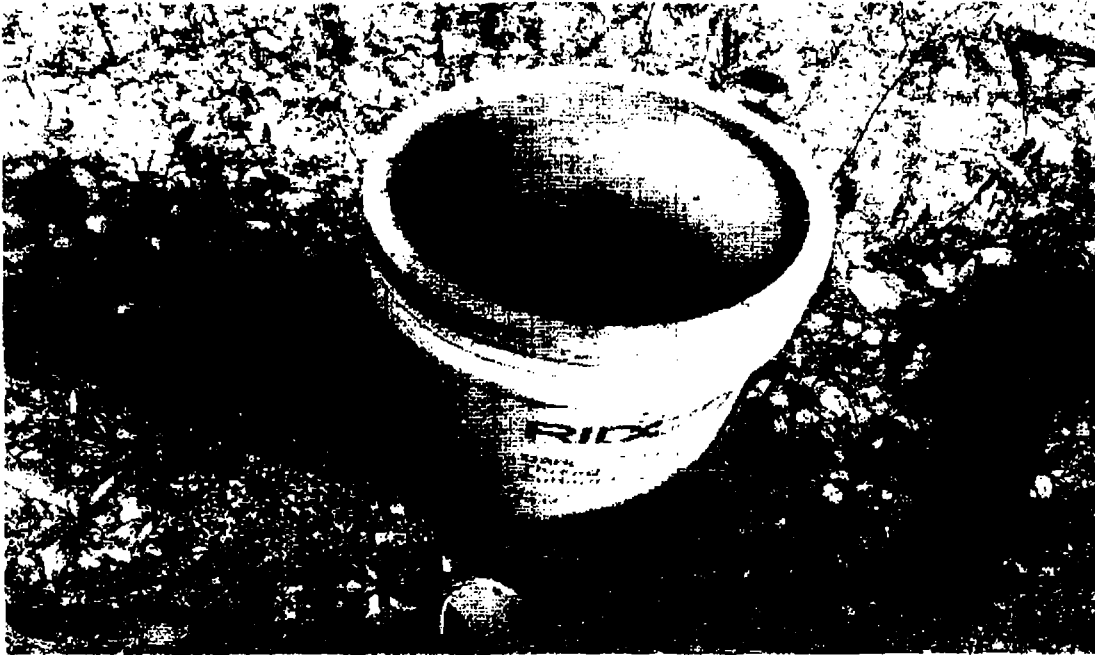
3. There are numerous containers scattered throughout the site. Containers range from pints, 1 - gallon, 5 - gallon, 55 - gallon & many storage tanks. Containers contain corrosive, solvents, oils, paints, cleaners & unknown containers with a clear liquid. Some of the containers are leaking onto the ground or already leaked onto the ground (see photos #5, #7, #12, #13, #14, #15, #16, #17 & #21).

Roll # _____ Photo # 5 Direction EAST
Comments: 5 gallon container marked thread cutting oil leaking into soil outside electrical shop.

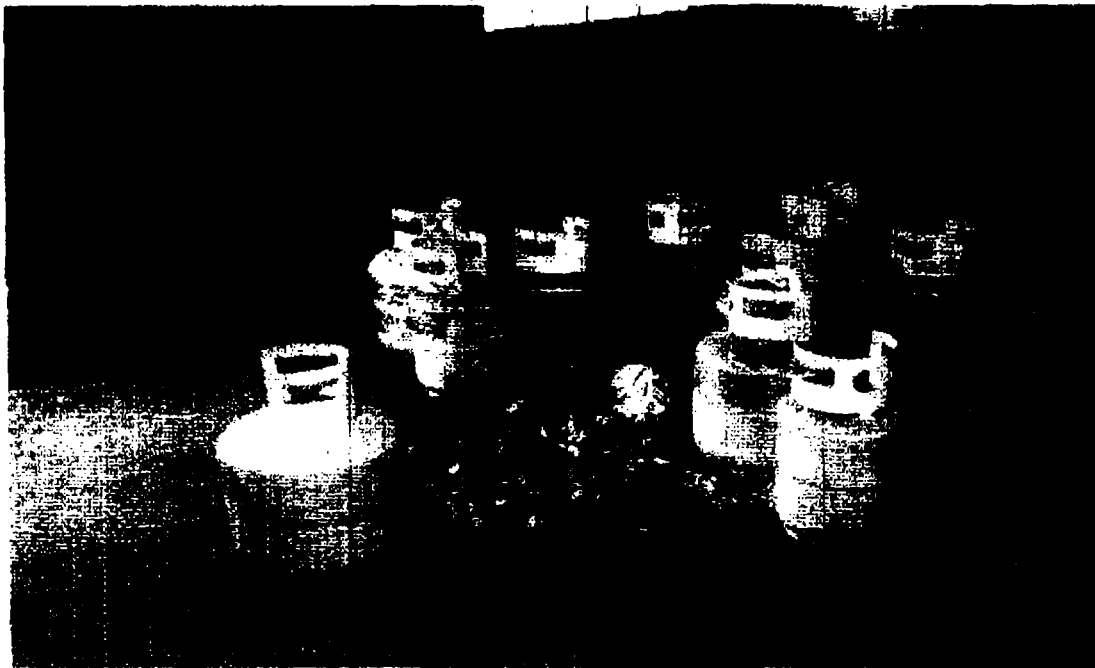
4. There is an approx. 100 cylinder tanks. Tanks are labeled MGW - refrigerant, propane, oxygen & acetylene. Some of the tanks appear to be full. The tanks are not secured (see photos #6 & #9).

Roll # _____ Photo # 6 Direction NW
Comments: NUMEROUS cylinders marked MCW-refrigerant.

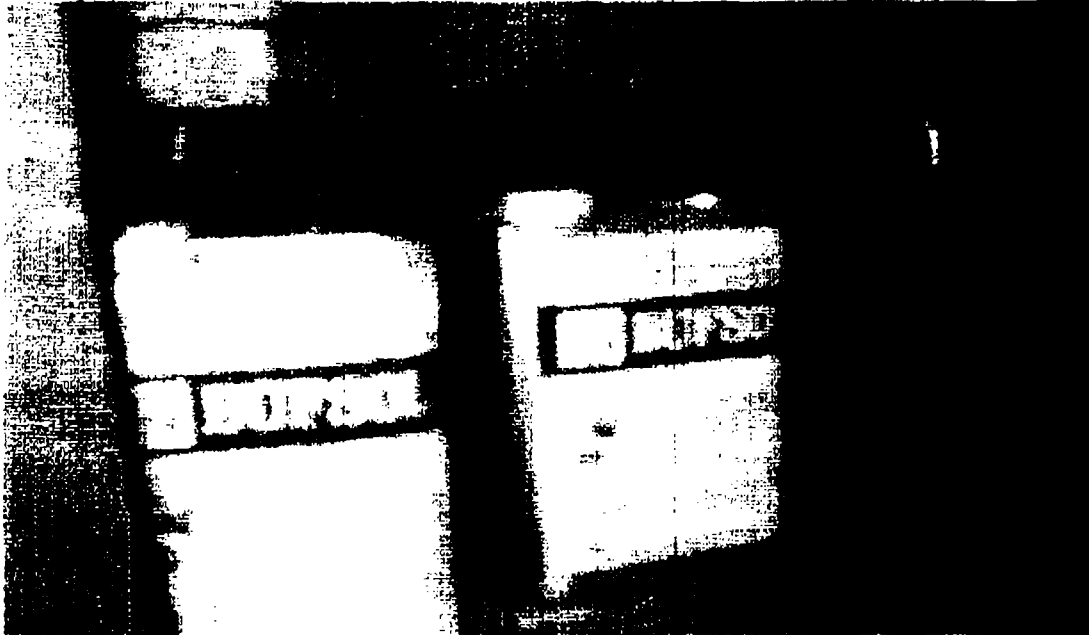
Roll # _____ Photo # 7 Direction NW
Comments: Cleaners, solvents & 2 gallons of Pang - Special solution
located in warehouse.

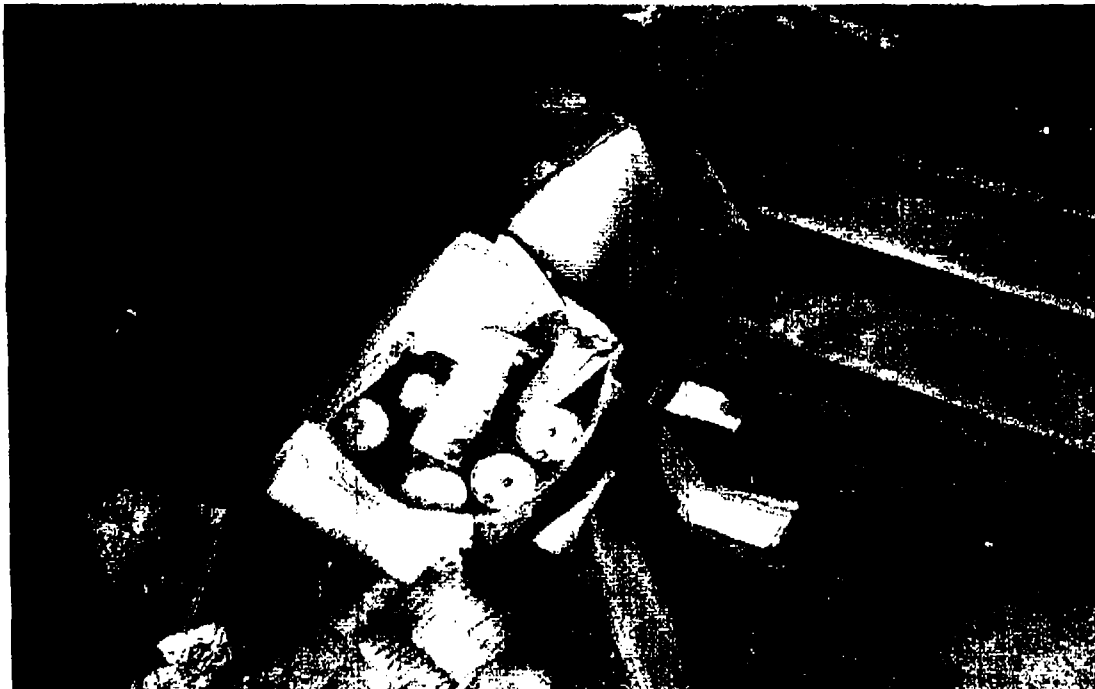
5. There are numerous lead acid batteries scattered throughout the site. Batteries are from motor vehicle equipment, backup / emergency lights and other back up power sources along with several transformers. Some of the transformed have green or blue labels. Others do not appear to be labeled containing or not containing PCB's (see photos #8, #22 & #23).

Roll # _____ Photo # 8 Direction North
Comments: Lead acid batteries located in warehouse.

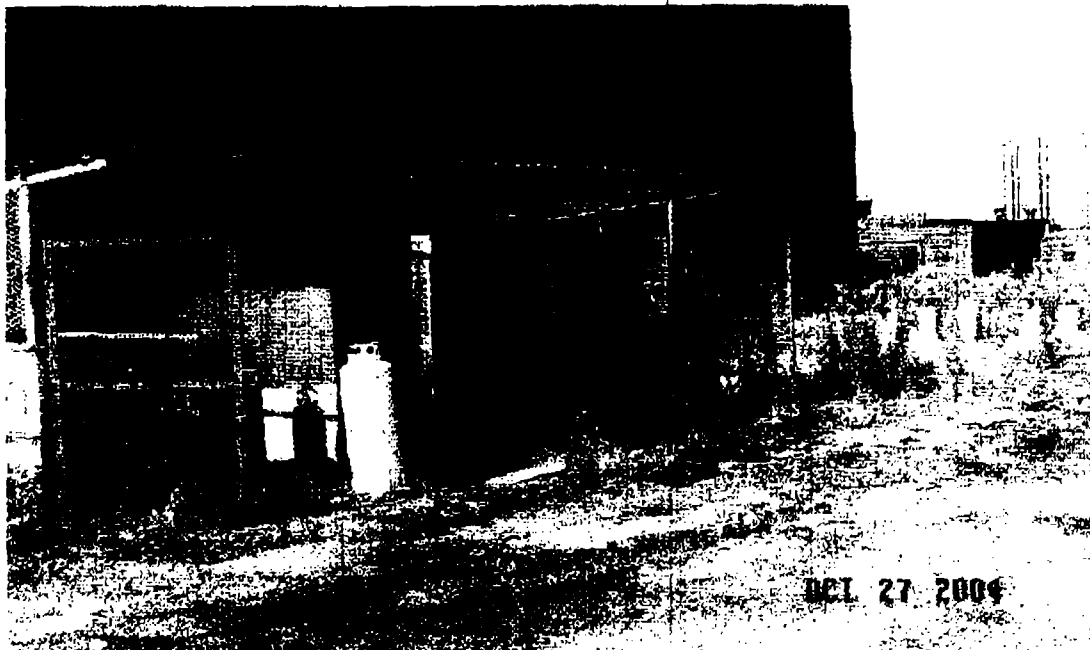
Roll # _____ Photo # 9 Direction NW
Comments: Approx. 80 cylinders unsecured on site. Unknown if empty or full.

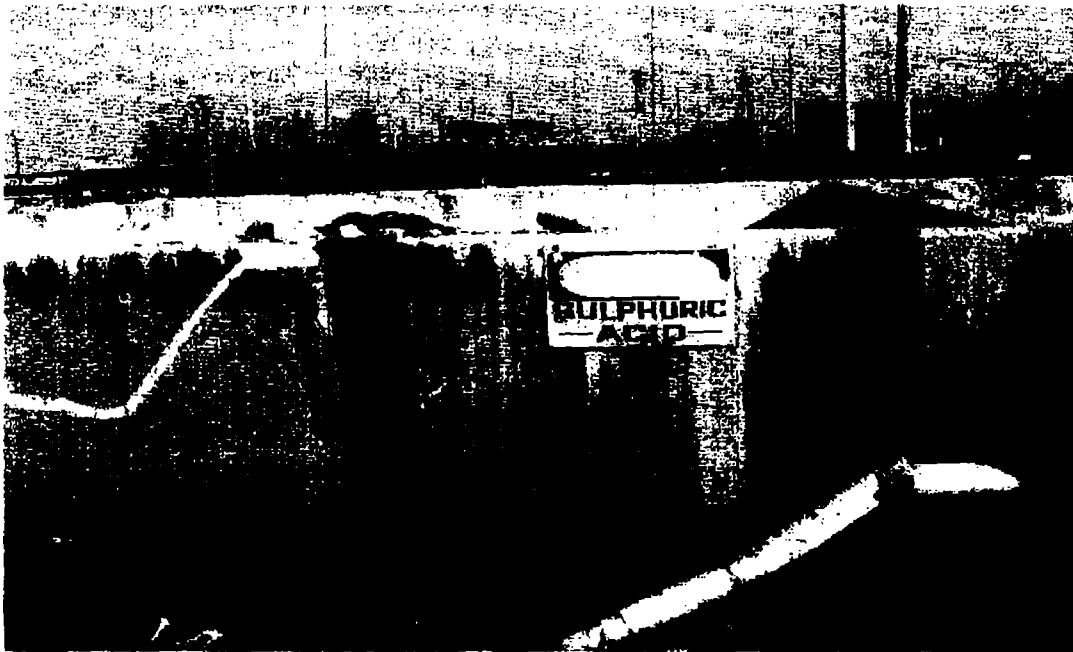
Roll # _____ Photo # 25 Direction East

8. There are minor sulfuric acid odors permeating around a concrete secondary containment area. It appears there was a sulfuric acid tank that was taken apart by unknown individuals. I tested the liquid inside the containment area with pH paper. I also tested the debris located outside the containment area and recorded a pH 0 (see photos #24, #25 & #26).

Comments: Debris + liquid with a pH 0 located inside containment area.
